[Docket No. FAA-2023-1814; Project Identifier AD-2023-00773-T; Amendment 39-22541; AD 2023-17-14]

Airworthiness Directives; The Boeing Company Airplanes

Final rule; request for comments.

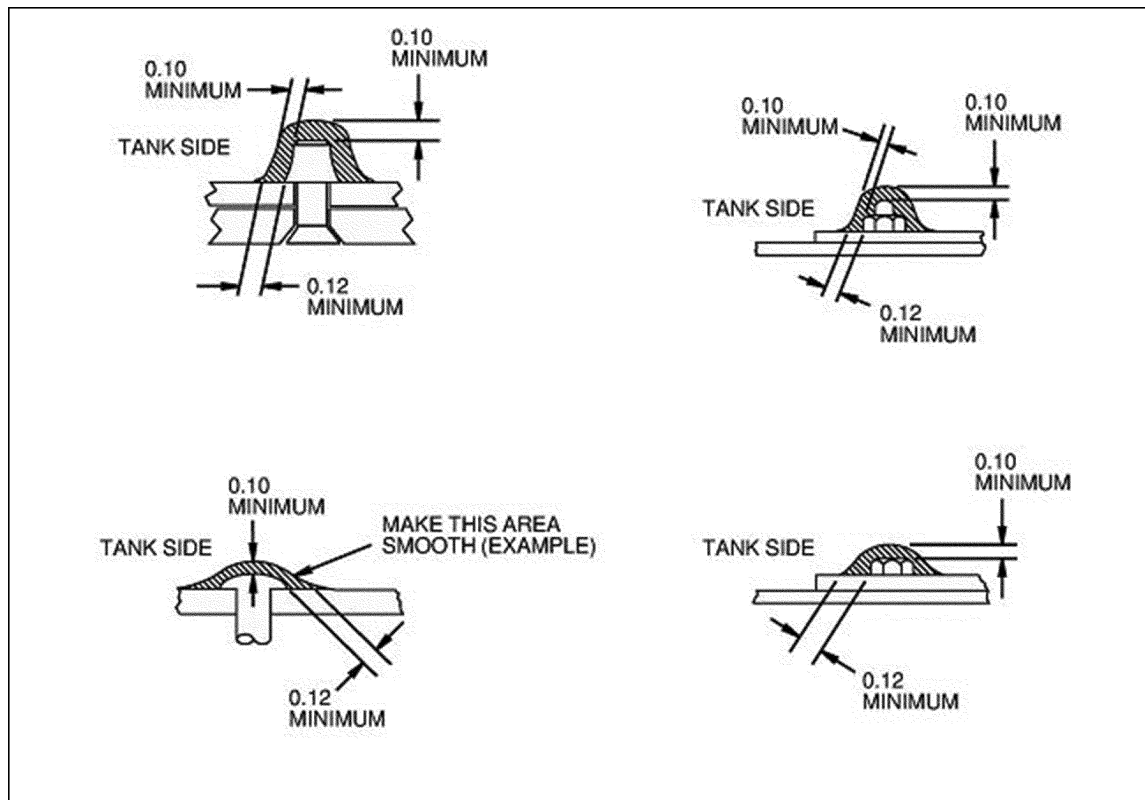
Figure 1 to paragraph (h)(4) – Cap seal minimum thickness (all dimensions in inches)

required by the requirements bulletin. A cap seal of insufficient thickness may fail to contain a spark resulting from a lightning strike, similarly compromising the fault tolerance of the fuel tank lightning protection. This AD specifies the minimum thickness and sealant type for an applied cap seal, and requires replacement of any seal that was previously applied using a procedure that specifies an inadequate thickness.

(4) During application of any cap seal to a fastener, fastener head, and fastener threads and collars, as required by this AD, the cap seal must be applied with a thickness equal to or greater than the dimensions specified in figure 1 to paragraph (h)(4) of this AD.

(ii) All cap seals were applied using procedures with thickness dimensions greater than or equal to those given in figure 1 to paragraph (h)(4) of this AD.

(2) If any cap seal was applied using procedures with thickness dimensions less than those given in figure 1 to paragraph (h)(4) of this AD, or if the maintenance records do not definitively specify the procedures used: At the applicable time specified in paragraph (i)(2)(i) or (ii) of this AD, replace the cap seal in accordance with the Accomplishment Instructions of Boeing Alert Requirements Bulletin 777-57A0122 RB, dated October 8, 2021, using a cap sealing procedure with thickness greater than or equal to the dimensions given in figure 1 to paragraph (h)(4) of this AD.

(3) For any cap seal that was not applied, or for any cap seal that was removed for inspections and not replaced, or if the maintenance records do not definitively specify the procedures used: At the applicable time specified in paragraph (i)(3)(i) or (ii) of this AD, apply a cap seal of BMS 5–45 sealant using an accepted method with thickness greater than or equal to the dimensions given in figure 1 to paragraph (h)(4) of this AD.
